FINAL REPORT REGULATED HAZARDOUS MATERIALS SURVEY

1544 CONCORD ST. S. SOUTH ST. PAUL, MN 55075

LEGEND NO. 2503991

October 20, 2025

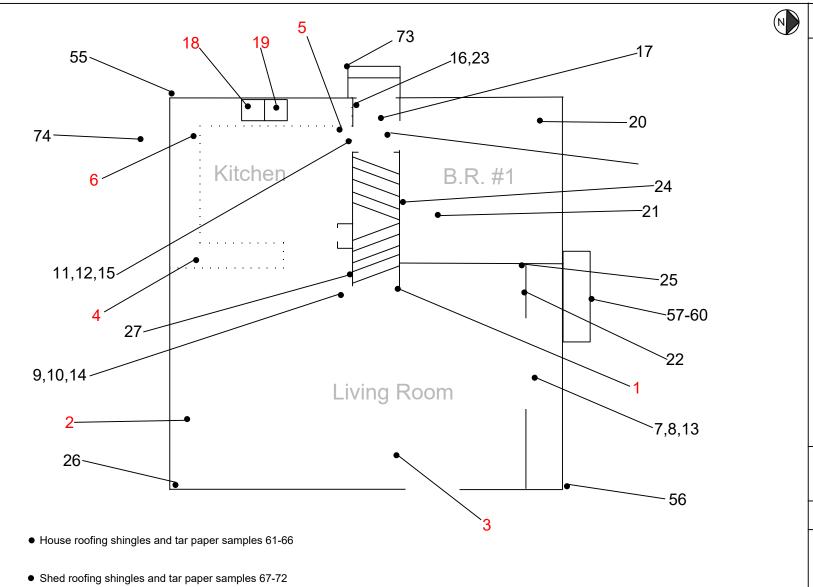
DIAGRAM #2

= Asbestos Sample Location Red indicates asbestos containing material.

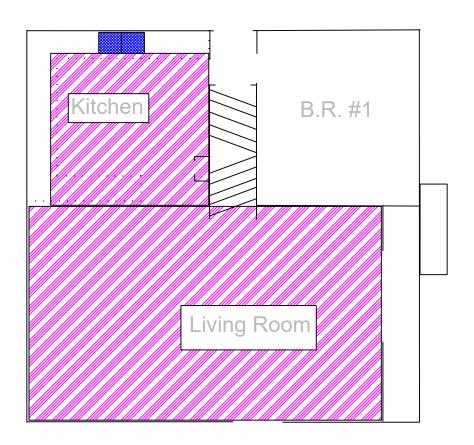
DIAGRAM #4

- Asbestos Containing Ceiling Texture (Approx. 315 Sq. Ft.)

- Asbestos Containing Sink Undercoating (1-Sink)

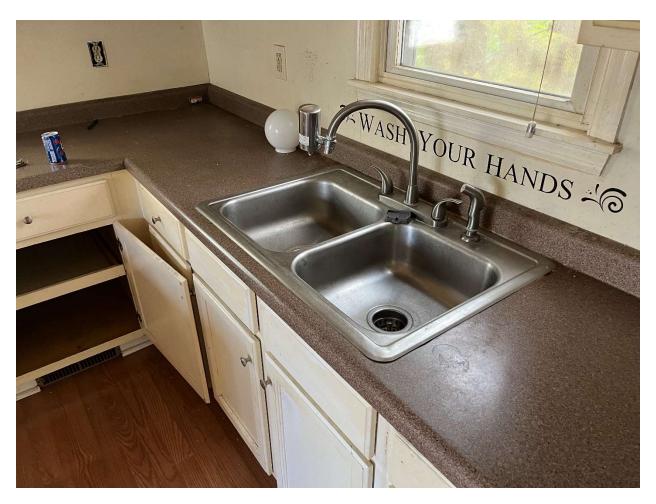
18	2503991-18	Kitchen	Sink Undercoating Black, Cementitious Homogeneous	2% Chrysotile	<1% Cellulose 97% Nonfibrous
19	2503991-19	Kitchen	Sink Undercoating Black Cementitious Homogeneous	3% Chrysotile	97% Nonfibrous

Photo #1 – Kitchen. Sink with asbestos containing undercoating.

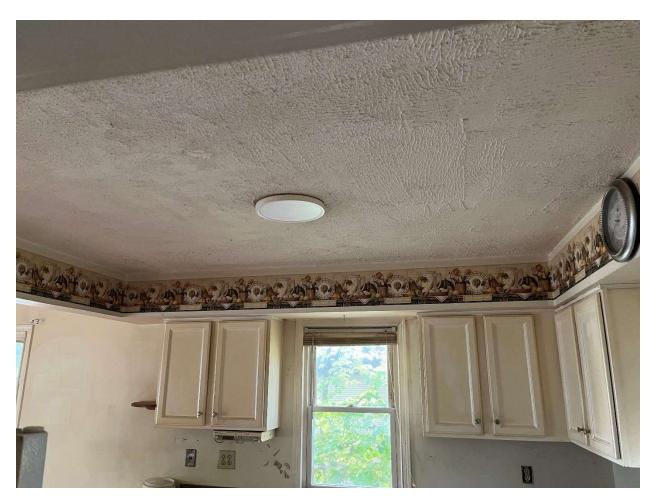
MATERIAL	LOCATION	ASBESTOS CONTENT	APPROXIMATE QUANTITIES
Sink Undercoating	Kitchen	2-3% Chrysotile	1-Sink
Ceiling Texture	Kitchen/Living Room	2-3% Chrysotile	315 Sq. Ft.

Photo #2 – Kitchen. Ceiling texture found to asbestos containing.

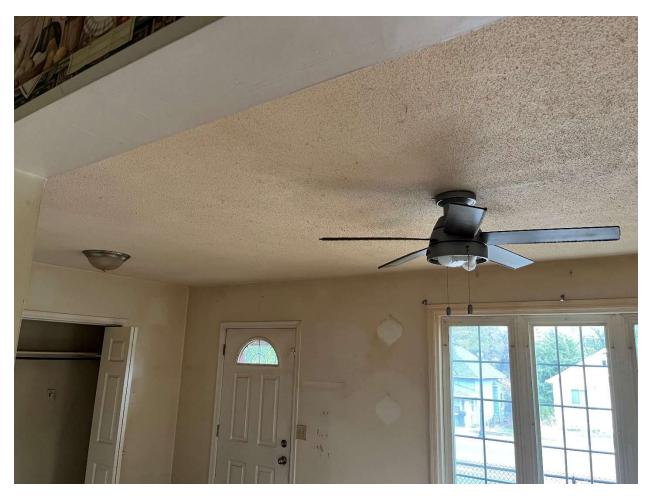
Photo #3 – Living Room. Asbestos containing ceiling texture.
